# Project Cargo Review of Risk Management Concerns and DSU Claim Issues

CBMU 2012 Semi-Annual Meeting

# Transfield Kemerton

Project – Simple Cycle Power Plant

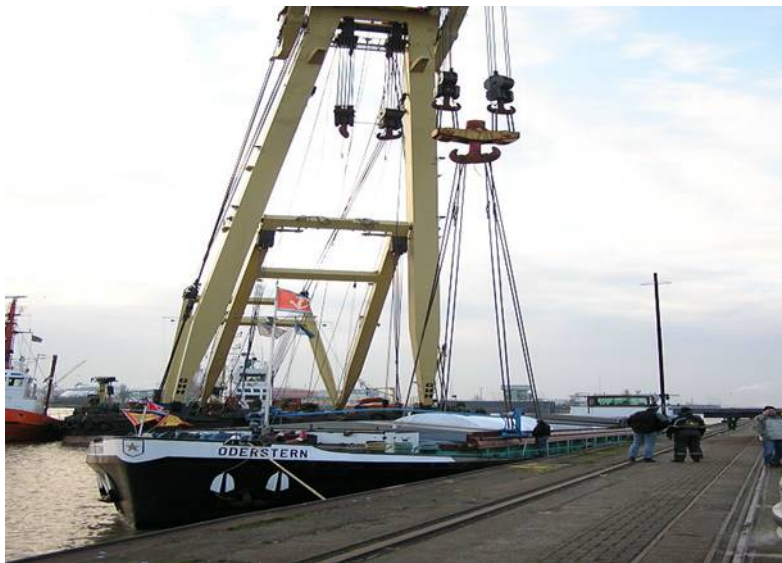
## Arrival by barge

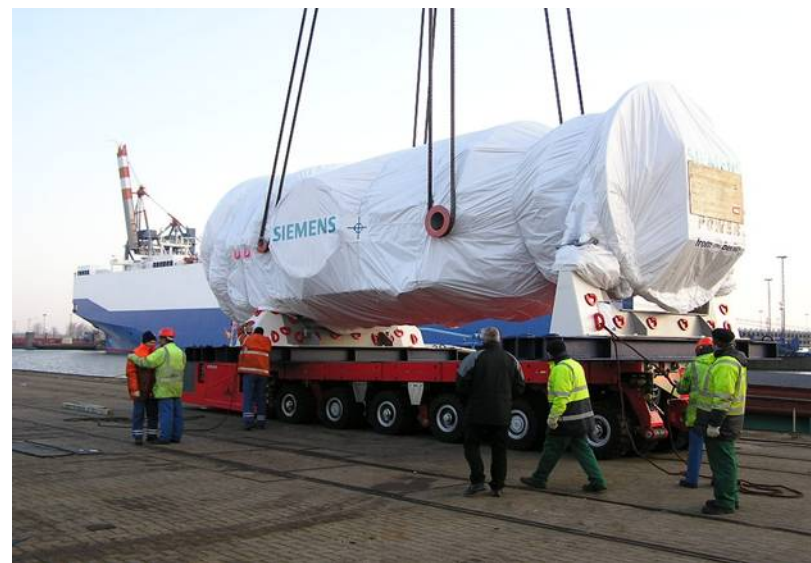
- 16<sup>th</sup> Feb 2005, GT discharge from river barge by floating crane
- Landed to a Scheuerle 6 axle platform trailer via steel beams and anti-friction mats.
- Secured using 15 x 12 tonnes lever tensioned lashing chains
- Trailer to be transferred about 150 meters to a lay down area
- 09.25 unit fully secured to trailer, trailer noted to be slanting in a fore and aft direction due to location of C of G. – Stevedores coffee break
- During this period, trailer operator believed to have been preparing trailer for movement, i.e. leveling.
- Trailer apparently tilted over in excess of 16 degrees and load toppled off, over barge and into the dock.

## Offload from barge

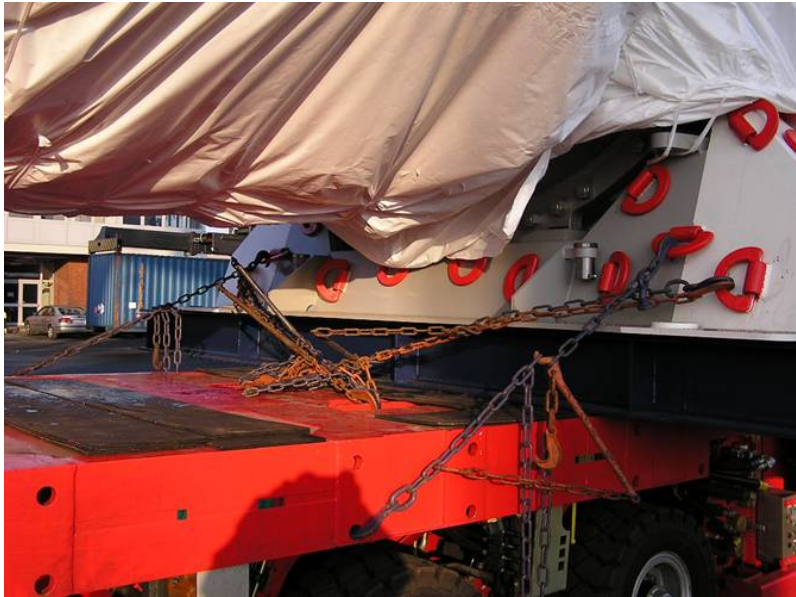
## Cargo lashing on transporter

- All parties onboard with need to expedite
- Replacement Turbine readily available
- Organized response driven by project experience claims personnel
- Importance of maintaining careful attention to quality of equipment used and ensure that attention maintained at all times. Substitute personnel should have been on site during coffee breaks and surveyor needs to pay attention to such issues

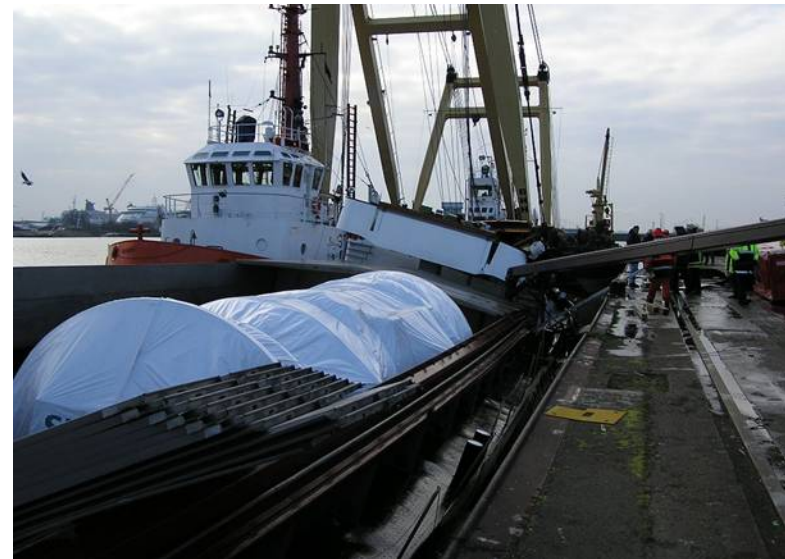
## Second Turbine

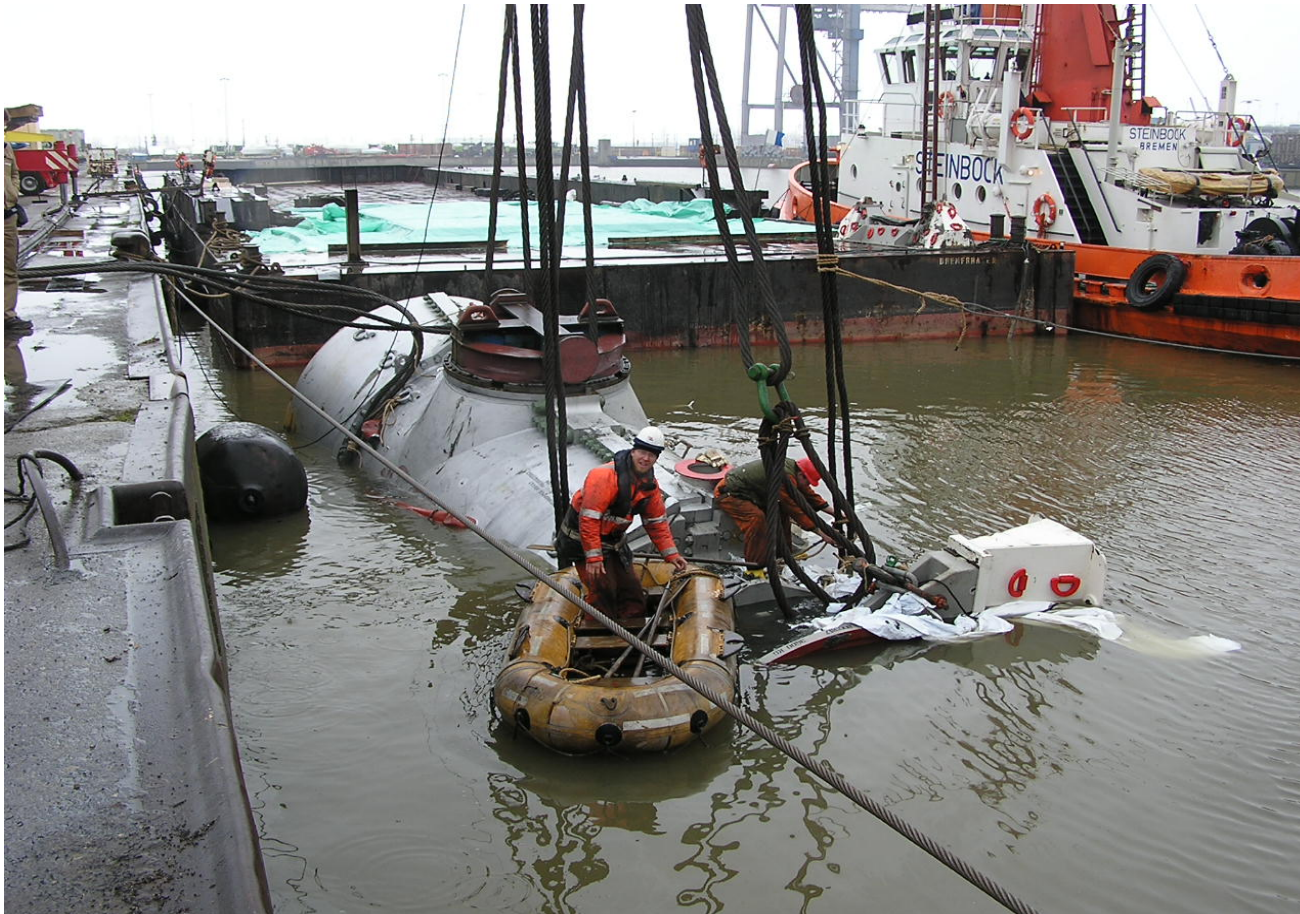
# Turbine Recovery

- DOL – 16<sup>th</sup> Feb
- Replacement Turbine Leaves Siemens – 19<sup>th</sup> February 2005
- Salvage Operation Complete – 21<sup>st</sup> February 2005

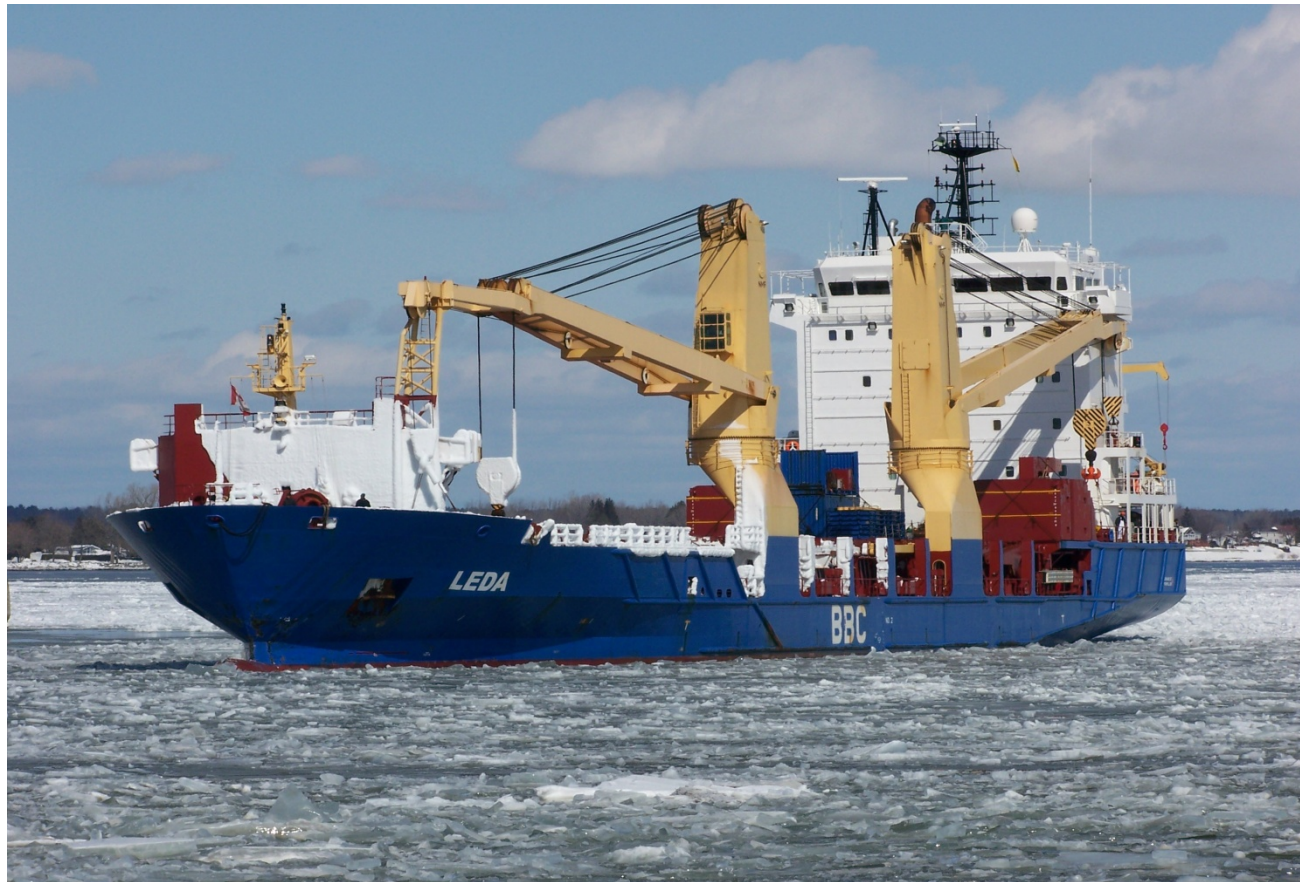
# Arrival of Vessel

- Cargo consisted of 14 HRSG Modules
- 12 intact and direct discharged to Rail
- 2 damaged – harps discharged to truck and stored at facility – frames discharged to rail

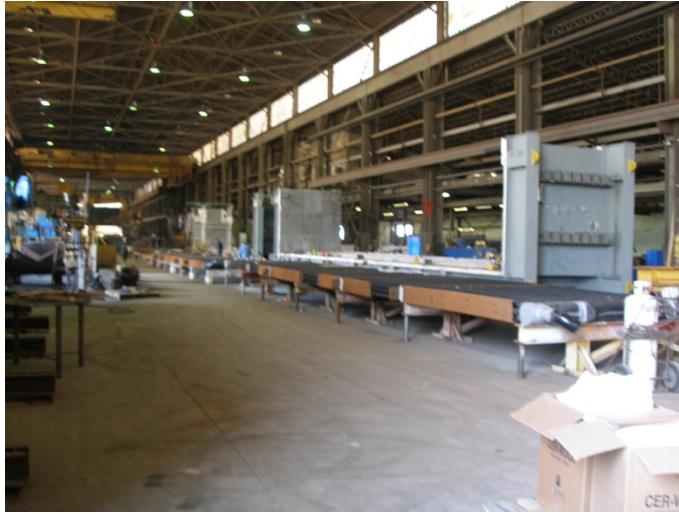
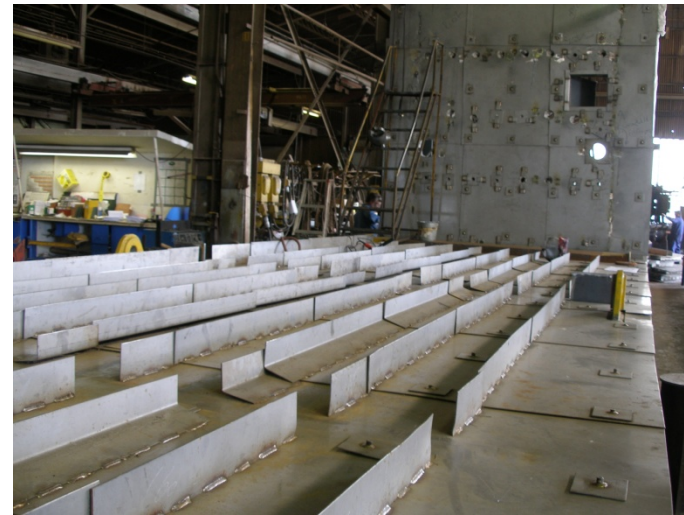
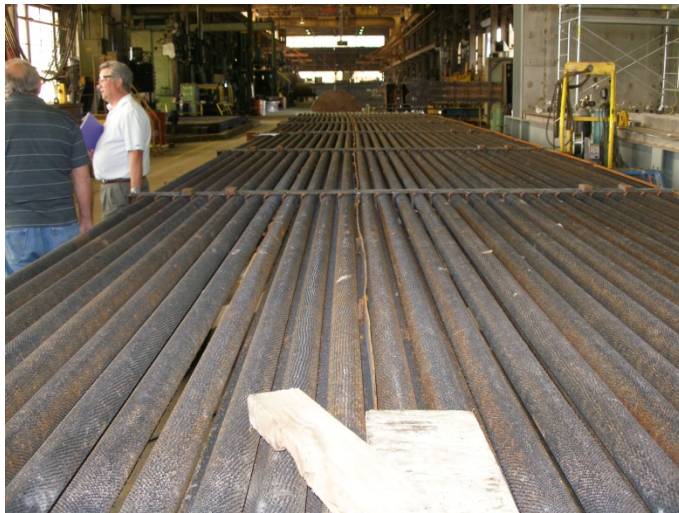
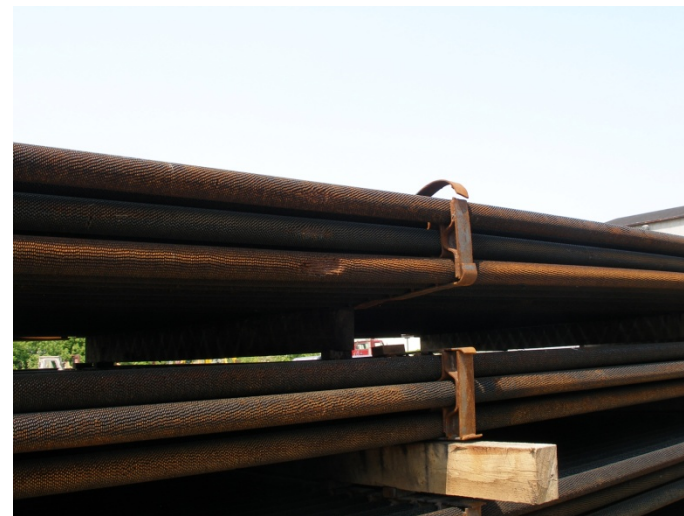
# Repairs in progress

- April 10 to 20 -Units loaded on Trucks
- April 11 to April 20 - Arrival Trenergy
- Early May 2007 - Repair supplies arrive Trenergy
- July 26, 2007 - Repairs completed
- Mid August 2007 - Modules Installed

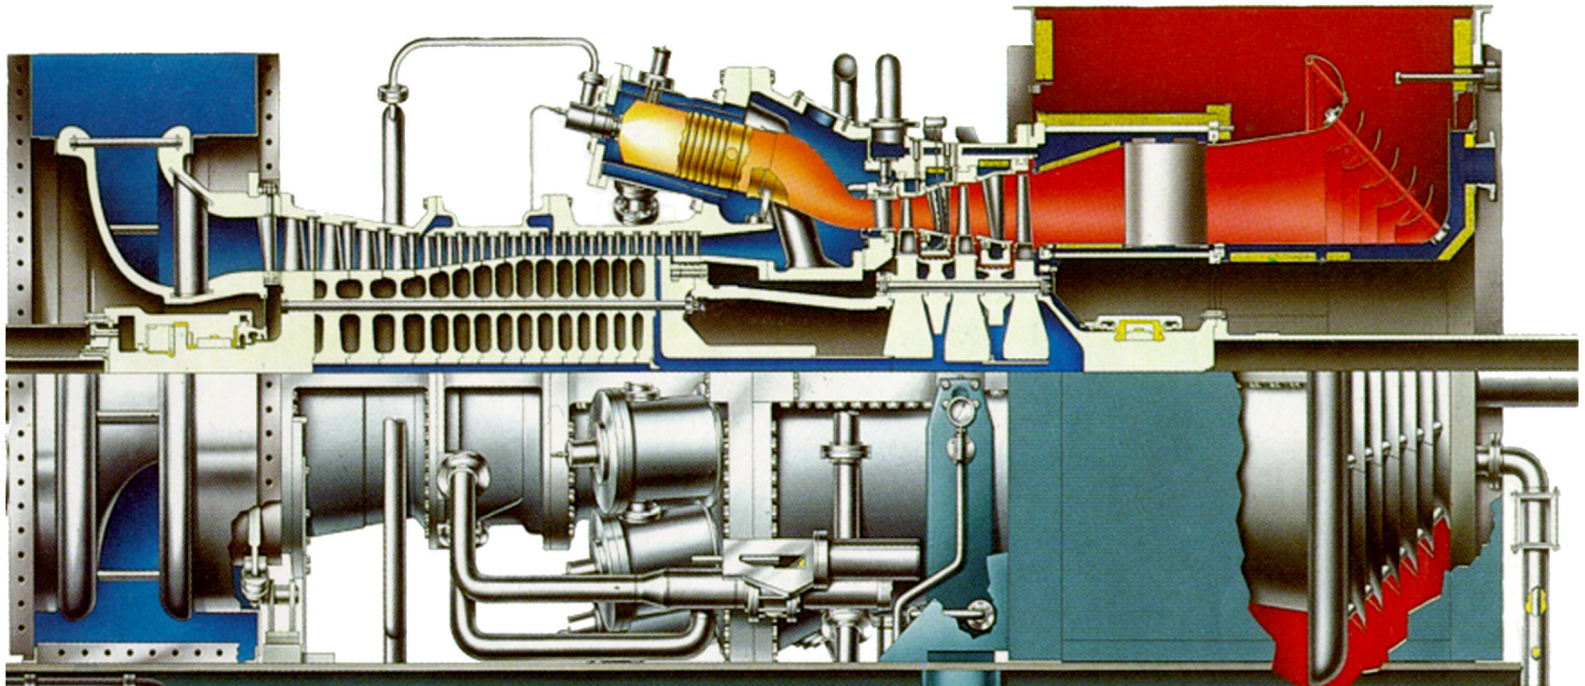
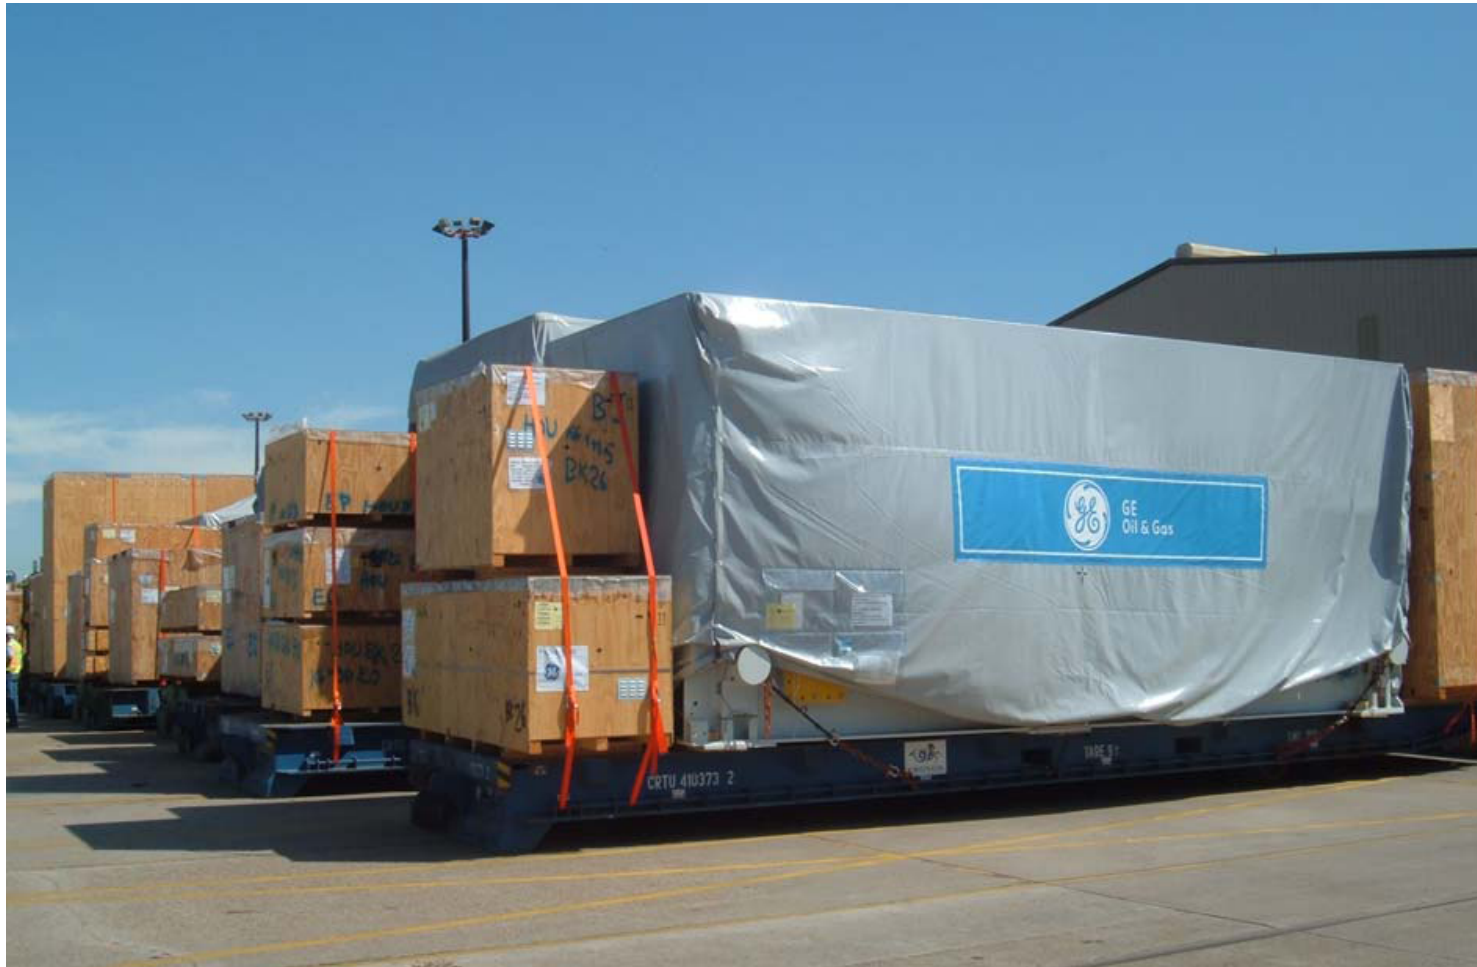
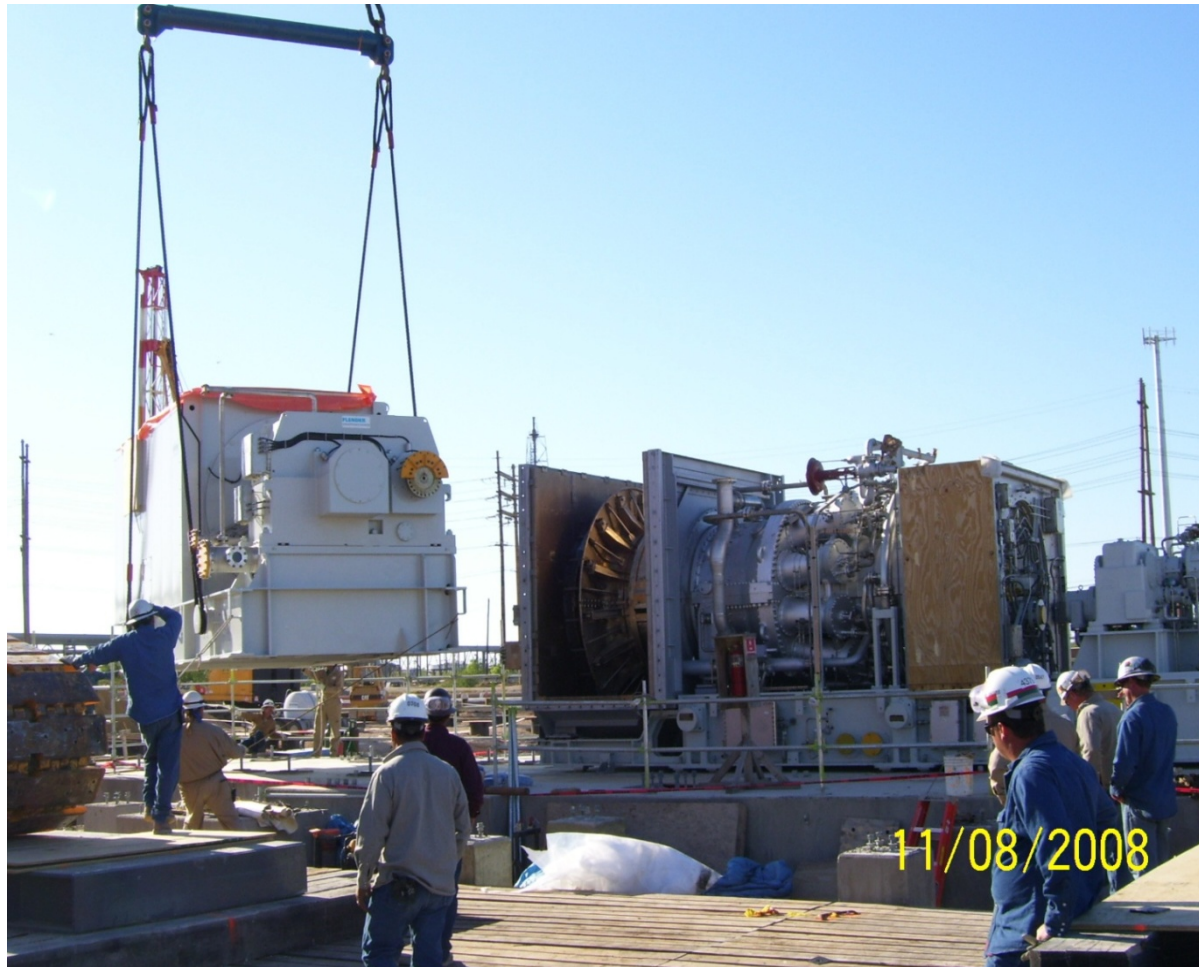
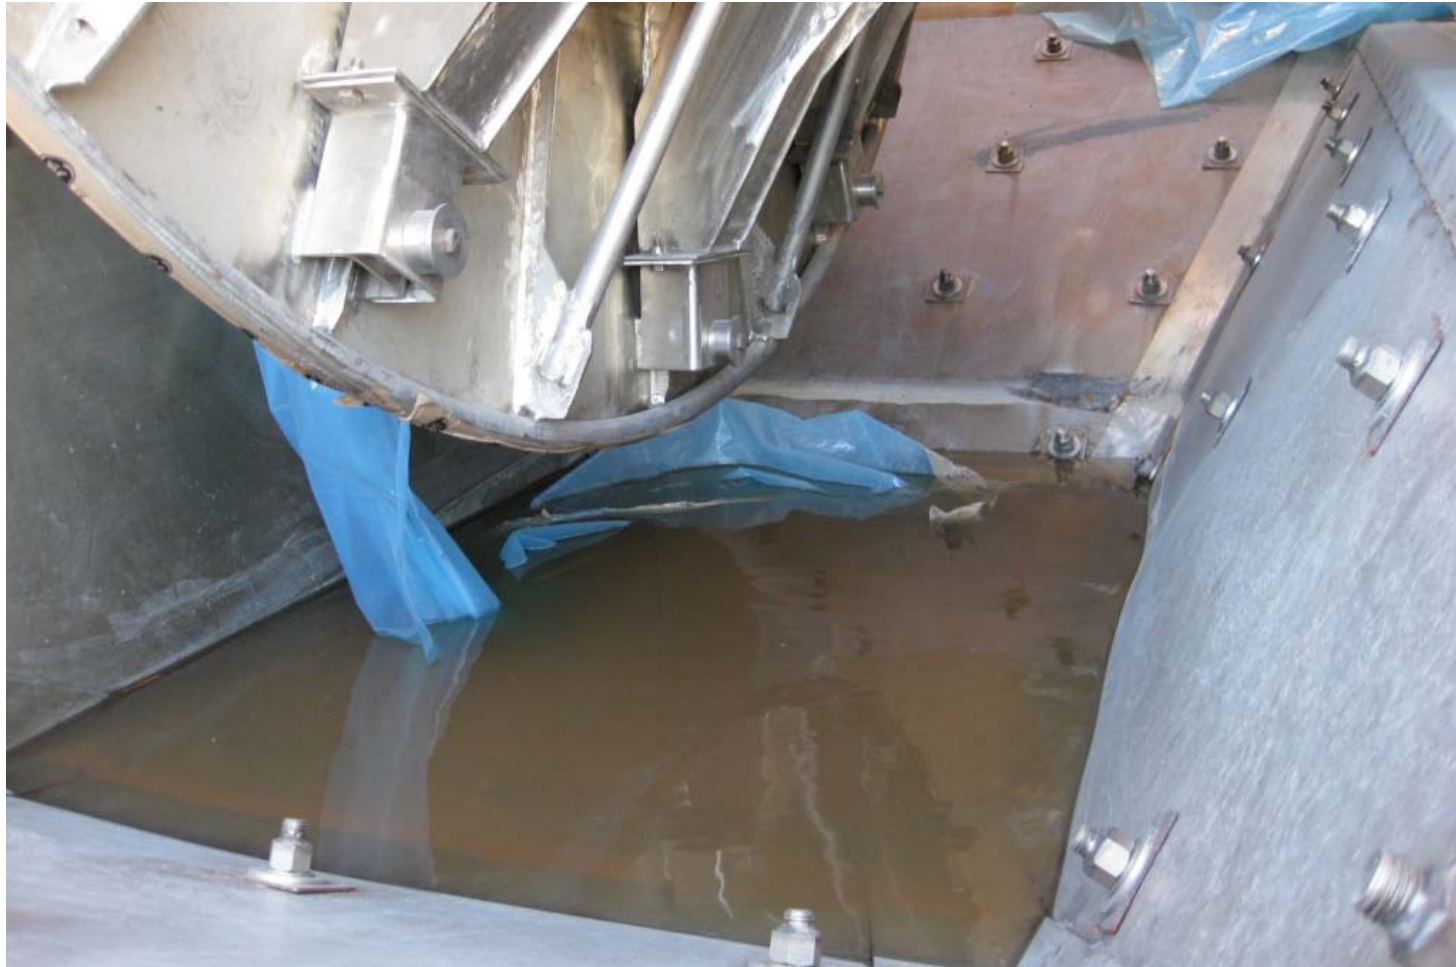
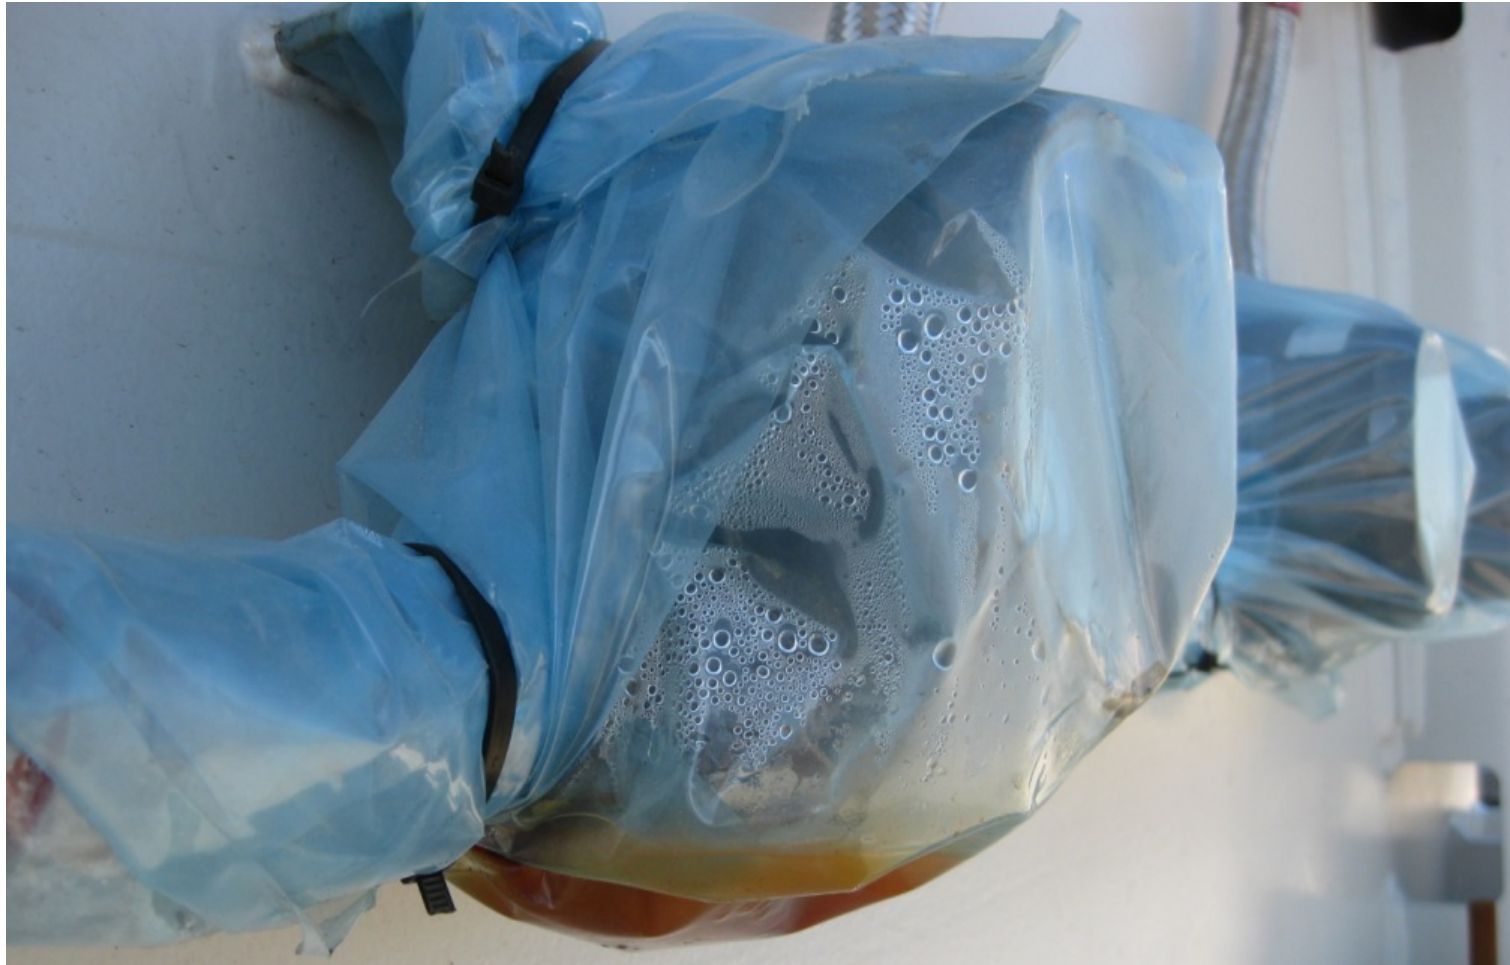
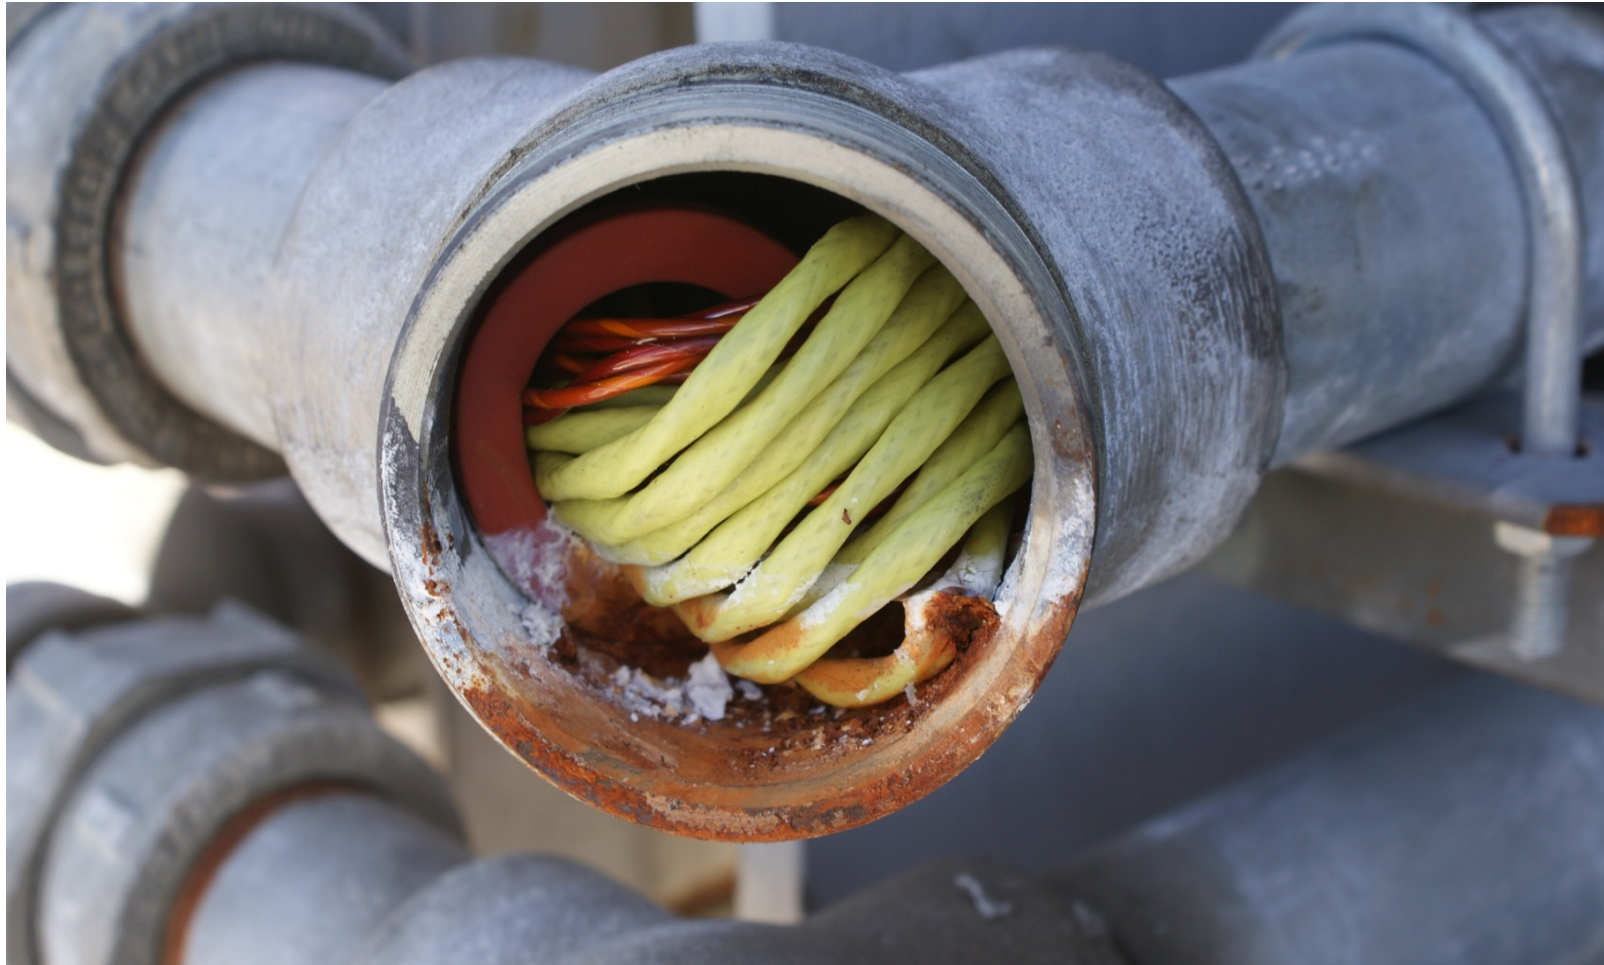
## MS6001-B

- Bechtel proceeds with installation of ancillary equipment and inlet and exhaust ductwork.
- Boroscopes completed by GE on all 4 units from 2/17/09 through 2/24/09. Severe corrosion of the turbine internals.
- Units 3 & 4 pulled and shipped to GE Houston repair facility in April 2009. Units 1 & 2 in Jan 2010
- Units 4 & 3 opened in Fall 2009, Units 2 & 1 opened in Winter 2010.
- Actual scope of damage less than originally thought based on borescope inspections. Scope of repairs primarily dismantle, clean, polish, some TBC refurbishment. Some non loss / warranty items noted.
- GE repairs estimated at amount less than replacement
- Bechtel associated costs incl. crane rental
- Total repair expense estimated in the millions

- Unit 4 – repaired, returned, installed at Site
- Unit 3 – repaired, returned to Site, awaiting install
- Unit 2 - at GE shop, water damage repaired, awaiting blades for non loss warranty work. Expected to be returned to Site early June
- Unit 1 – at GE shop, ETA for complete repair and return to Site – 7/13/10.

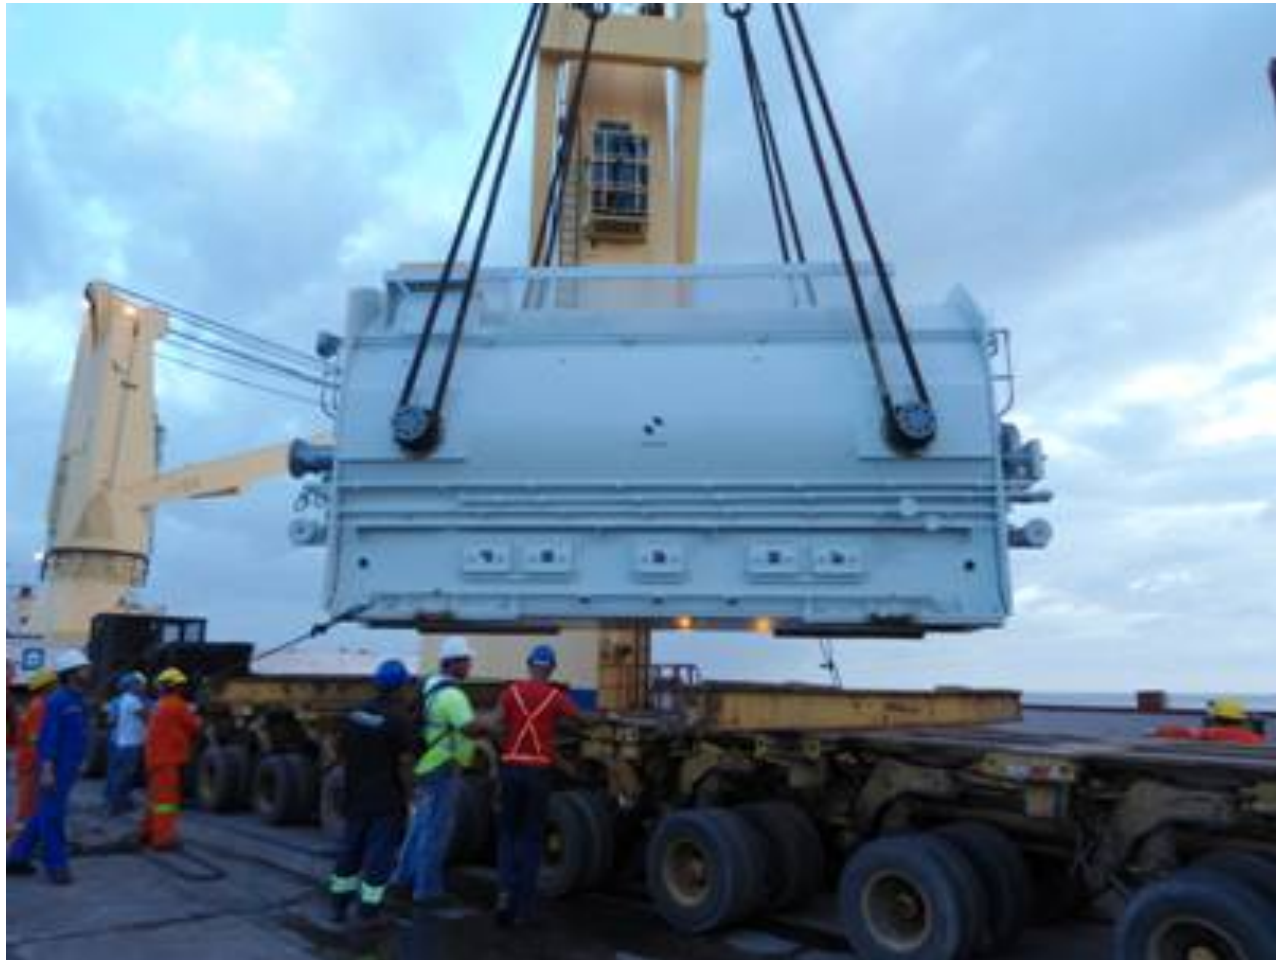
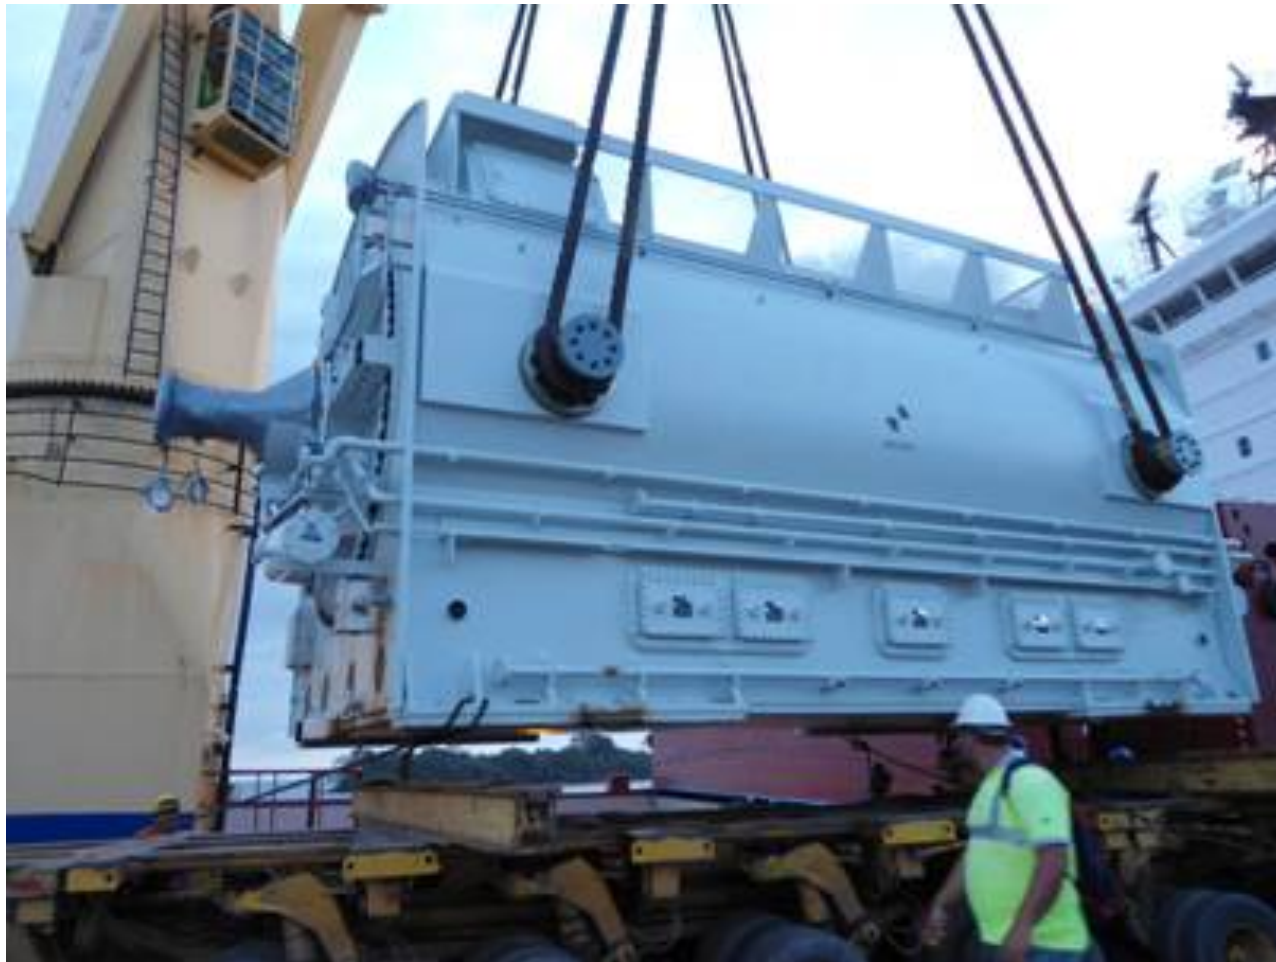
# MPX Parnaiba Generator Discharge

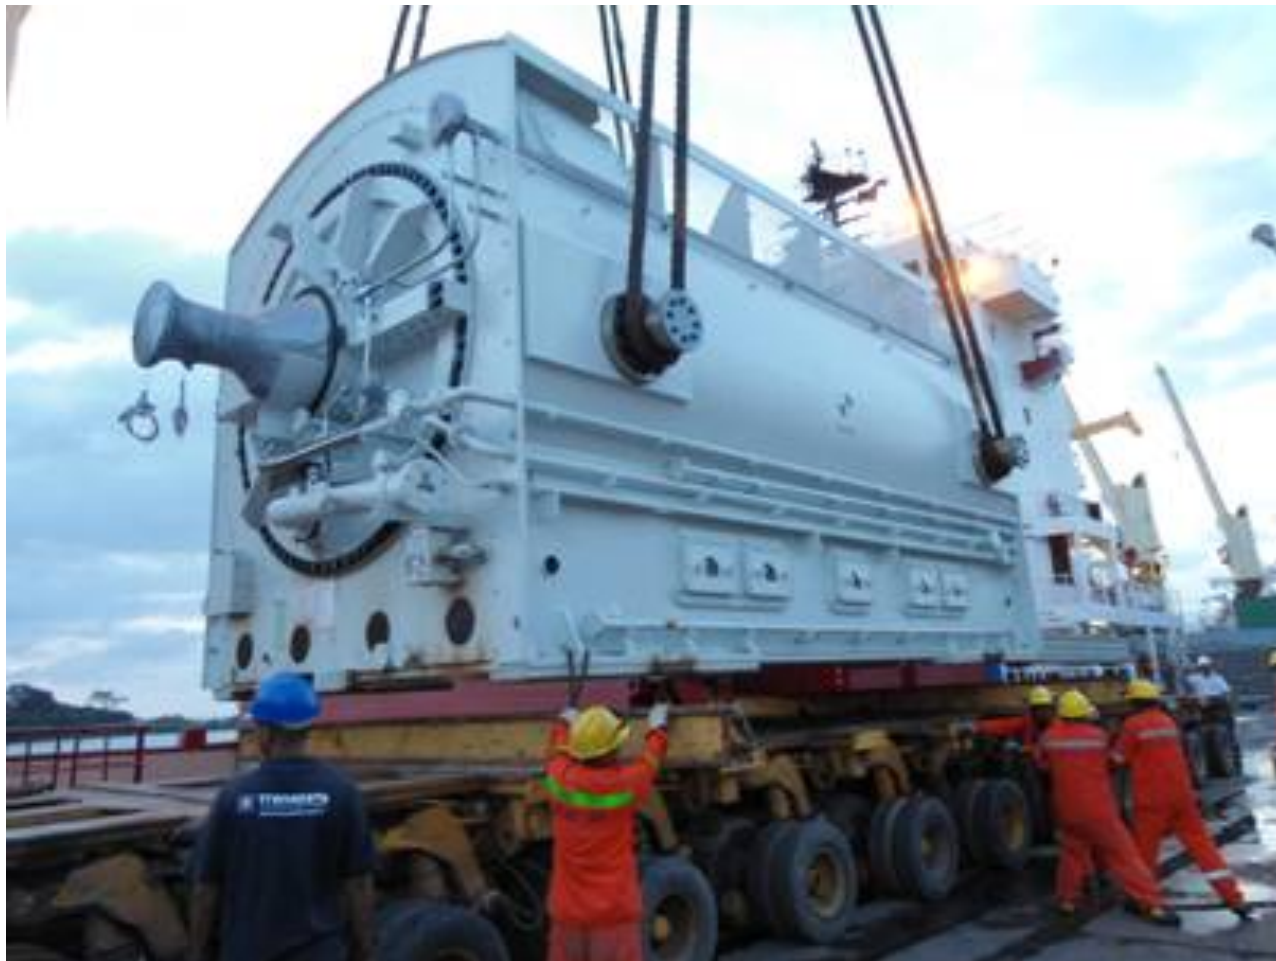
# MPX Parnaiba Placement on trailer

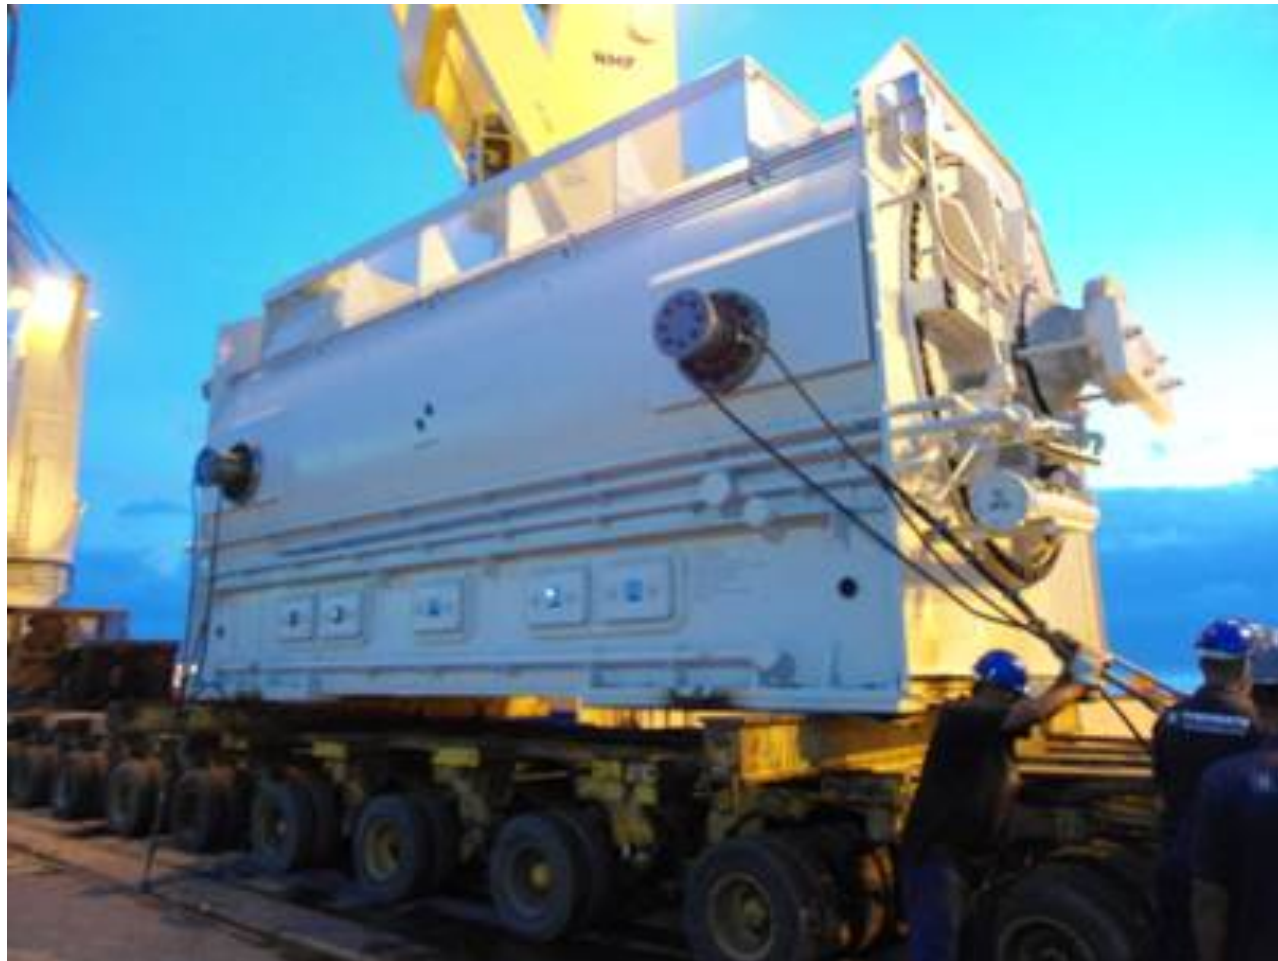
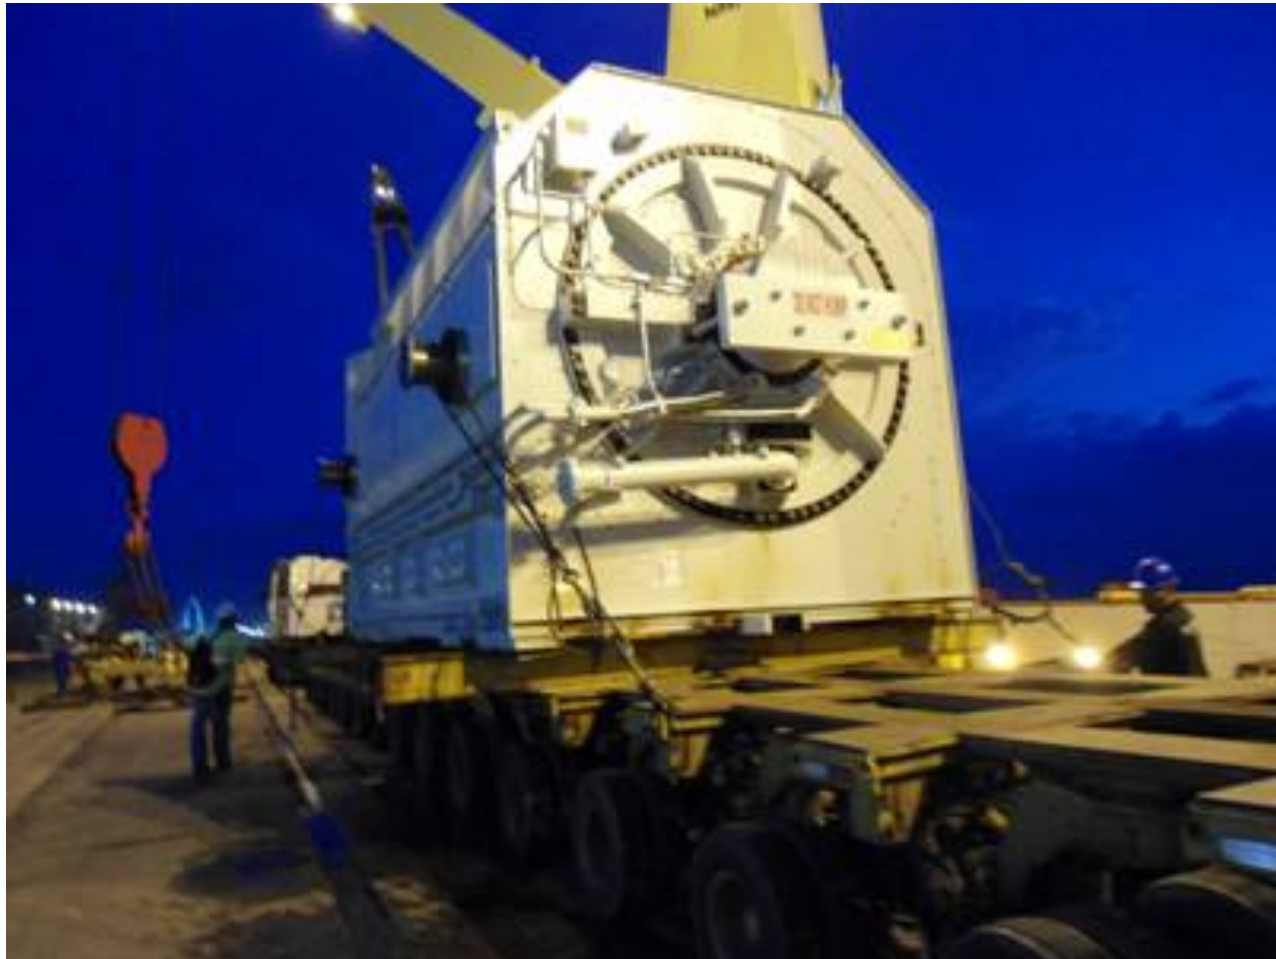
# MPX Parnaiba lashing

- Trailer changed from original move to this move
- Trailer inspection key
- Loss occurred last week
- Too early for much discussion

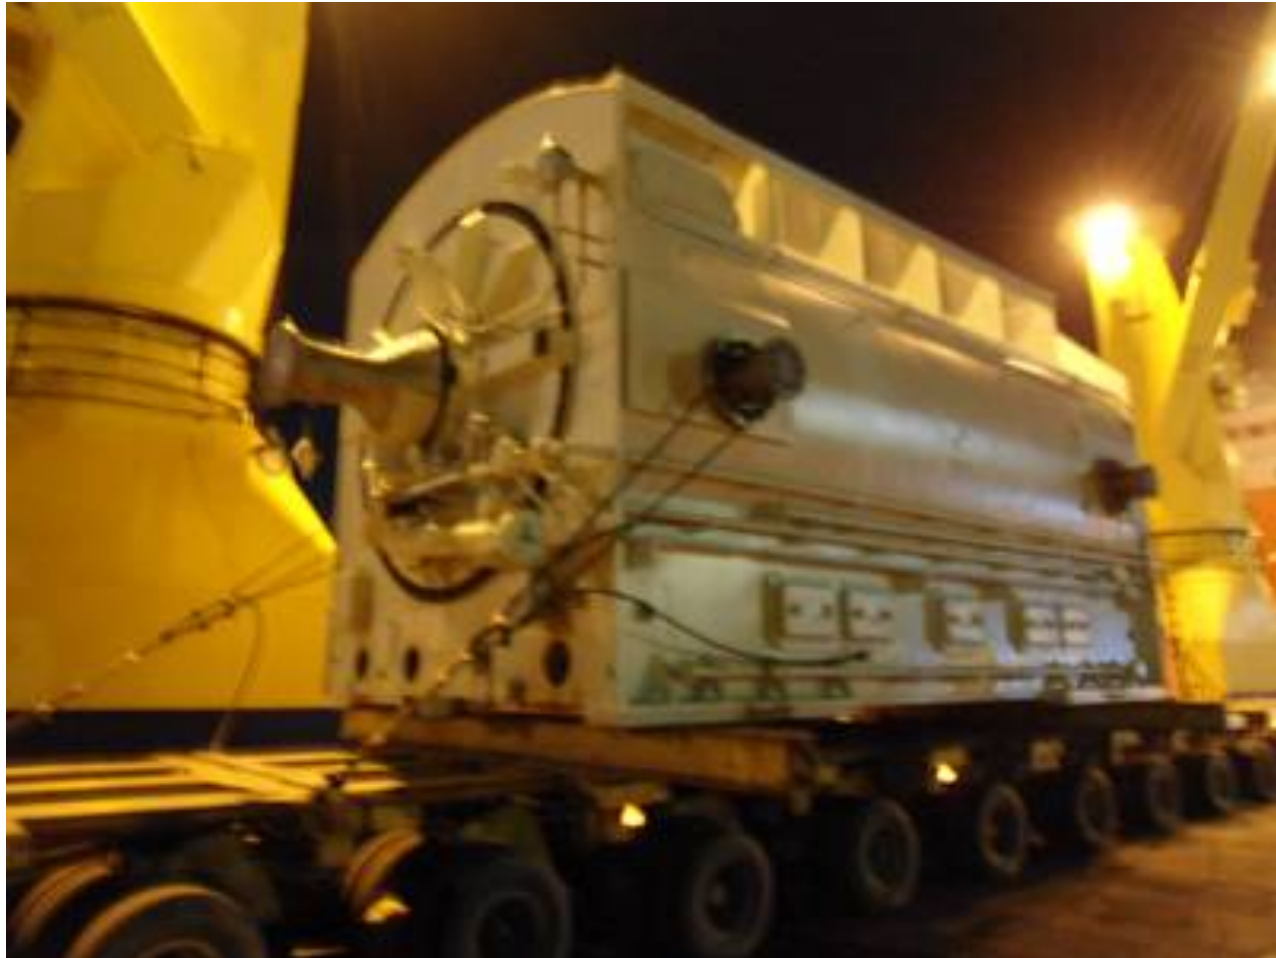
# MPX Parnaiba lashed to trailer
